*VSL PT to reduce joints and maintenance cost.*

Pilkington (Australia) Limited, a major Australian producer of glass, recently extended its existing float glass plant at Ingleburn, NSW, Australia.

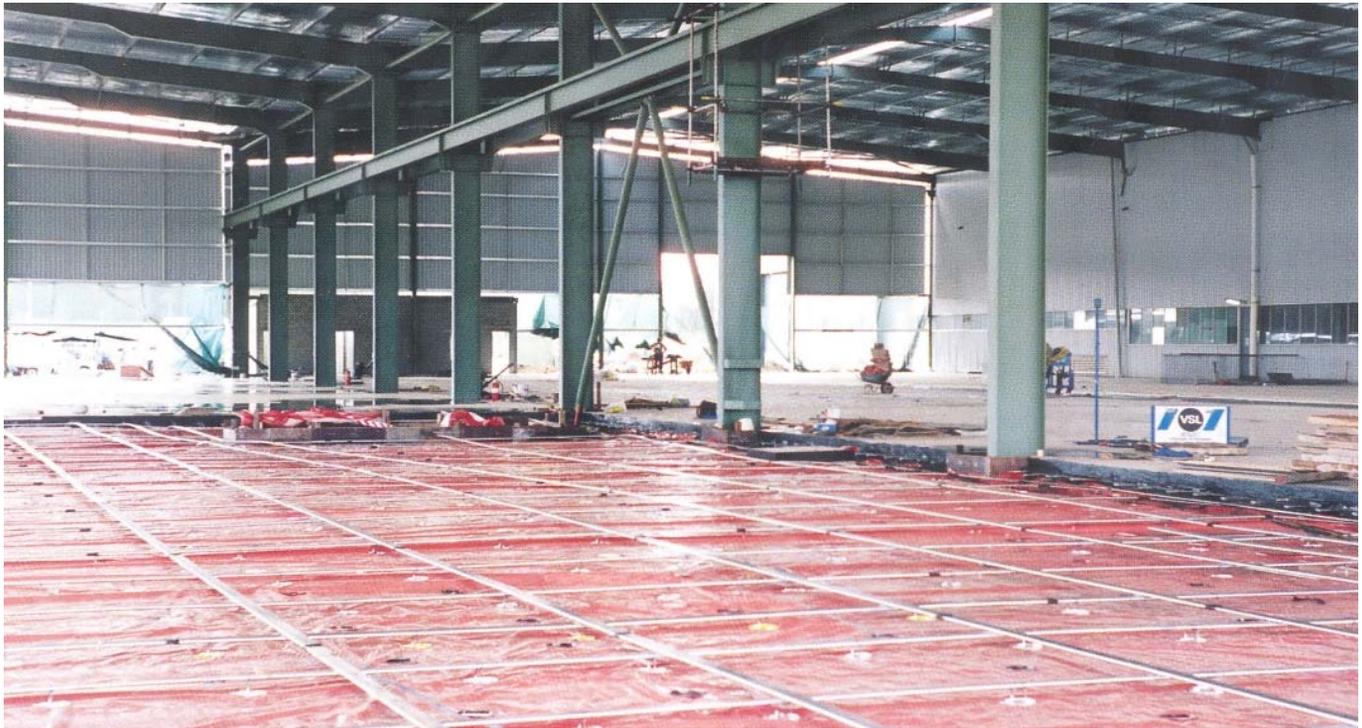
▲ The extension increases the stockroom by over 16,500 m<sup>2</sup>

The extension increases the stockroom by over 16,500 m<sup>2</sup>, provides a new laminating facility and adds heavy duty external pavements.

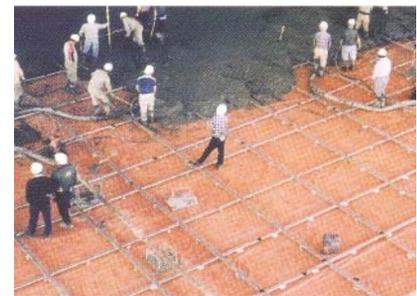
▲ Preparation of post-tensioning of the floor

The slabs were axially post-tensioned by tendons running in both directions and located at the centroid of the slab.

The slab was cast on a suitable foundation with a thin sliding layer of sand and plastic membranes. There was an edge thickening to accommodate anchorage. The early application of some initial prestress served to control initial shrinkage cracking because the entire slab contracts under the prestress by sliding. Final prestress application was designed to ensure that the slab would remain permanently in a state of compression, even under the most adverse combination of applied wheel or post loads and temperature effects.

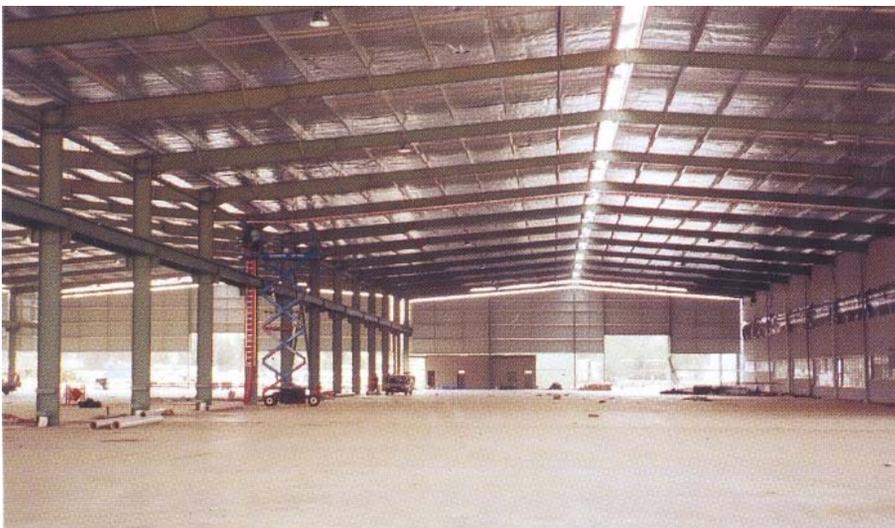
▼ 26,000 m<sup>2</sup> of post-tensioned concrete slabs on grade completed.
